EXISTING CAMPUS CONDITIONS

HISTORY OF THE CAMPUS

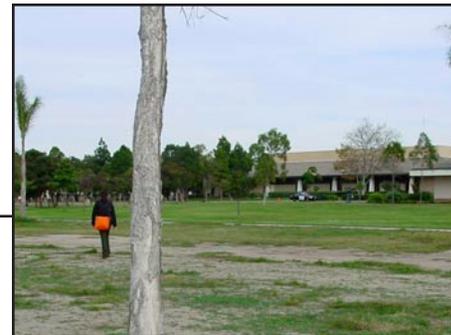
This extensive open space along Rose Avenue is a currently underutilized "no man's land" on campus.

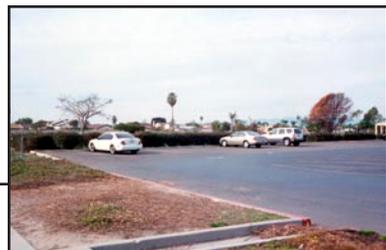
View of existing parking lot B from Bard Road. Lot B is one of the parking areas currently used for the Oxnard Community Marketplace.

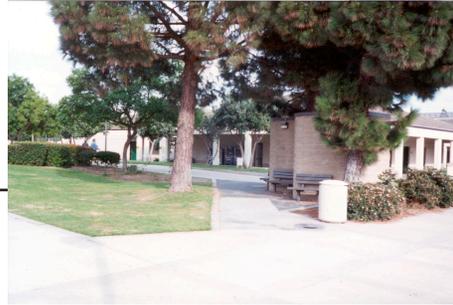
Some key areas of the core campus lack visual clarity and design intent: Major buildings are obscured, pathway destinations are unclear, landscape and hard-scape areas form a patchwork of spaces of heterogeneous size, shape, materials and intended use.

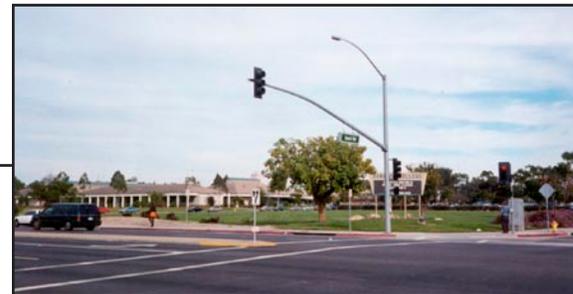
The southwestern edge of campus at Rose Avenue and Bard Road lacks a strong unified system of landscaping and campus identification.

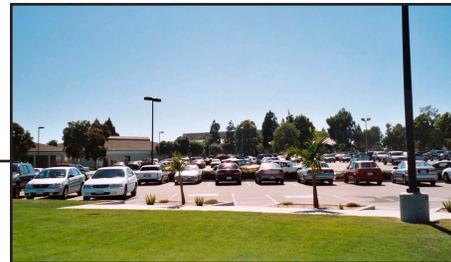
This parking lot currently located within the campus core will provide a large site available for building development.
