GEOTECHNICAL STUDY

PARKING STRUCTURE MOORPARK COLLEGE

Geotechniques

Subject: Geotechnical Study, Parking Structure, Moorpark College, Moorpark, California

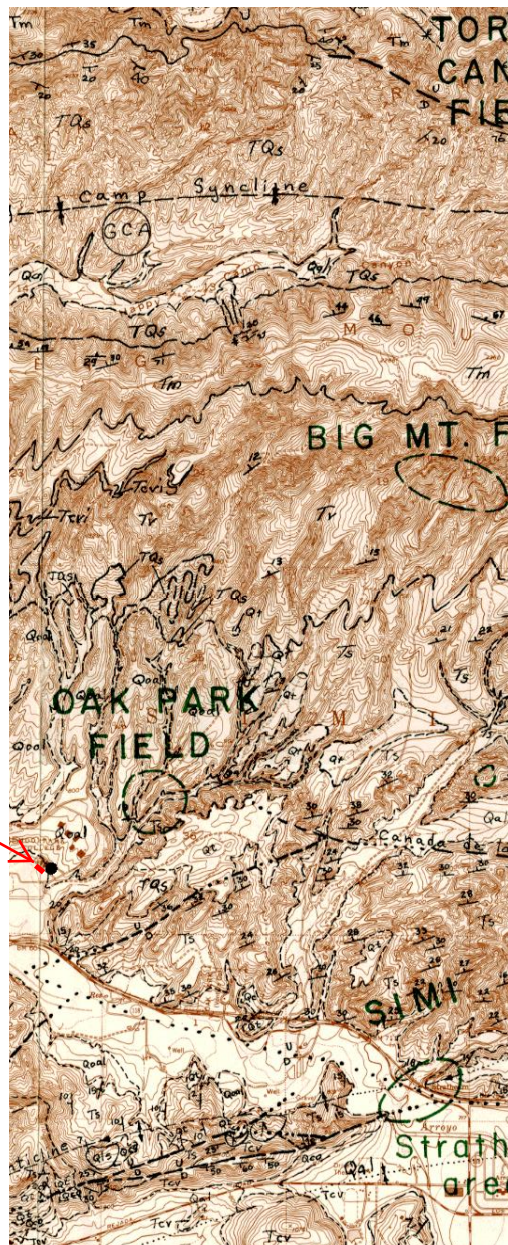
BASE MAP SOURCE: Geologic Map of Southern Ventura County, California, Showing Mineral Deposits, compiled by California Division of Mines and Geology, Preliminary Report 14 (Weber et al., 1973).

**REGIONAL GEOLOGIC MAP
FROM WEBER ET AL. (1973)**

Hazard maps by CGS (2001) and Ventura County (2007) do not show landslides or areas susceptible to earthquake-induced landslides on the Ventura College campus. Landslides are not mapped on or immediately adjacent to the campus according to Dibblee (1992), Irvine (1990), and Weber et al. (1973).
